Polyurea, waterproofing system at the Huntsman site : seven years later

In 2010, Huntsman refurbished the roof on one of the site buildings located in their European Head Quarters in Everberg (Belgium).

It was decided to install a green roof based on Vydro® foam technology and to use polyurea as a fast setting seamless membrane securing the water tightness of the whole system without the need to remove the existing 20 year old and worn bitumen layer.

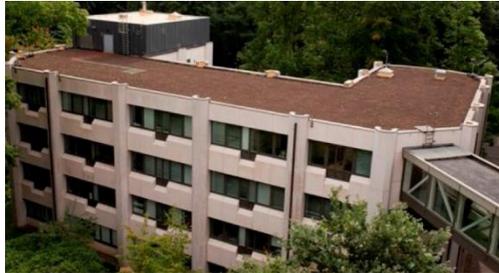
Fig.6

All of the work, covering more than 600 m², was successfully completed in just three days (fig 6).

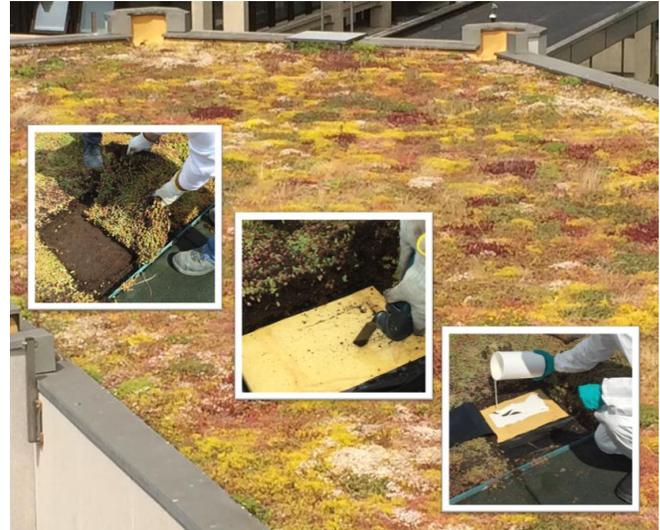
A small part of the polyurea membrane was cut out on the green roof after removal of plants and subsequent layers. The damaged area was directly repaired by using a cold-applicable polyurea with a cure time of about 7 minutes, giving the team enough time to mix the isocyanate and the amine blend on site, to pour it out and seal it again with the root resistant PE foil (see fig 7.)

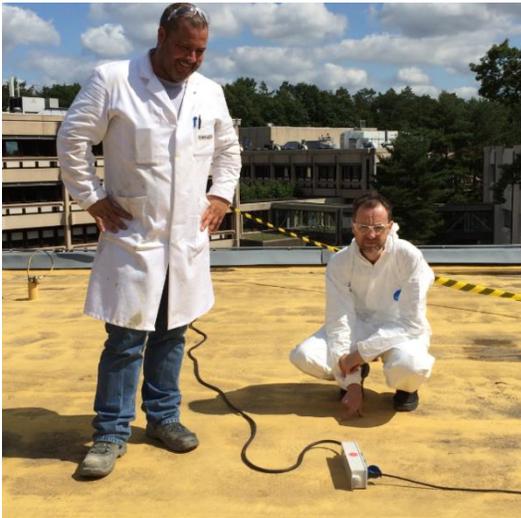
Another polyurea sample was taken on an upper area of the roof (fig 8.) which is not a part of the green roof. The polyurea functions as a roof coating having direct weather exposure. Inspection of this roof coating revealed no defects like blisters or adhesion loss except for one single crack of 10 centimeters.
