## Case study: Waste Water Treatment Plant in Italy, BASF Construction Chemicals

Our reference in Cittadella (Italy):  
Waste Water Treatment Plant

### Waterproofing to avoid leakage and concrete damages

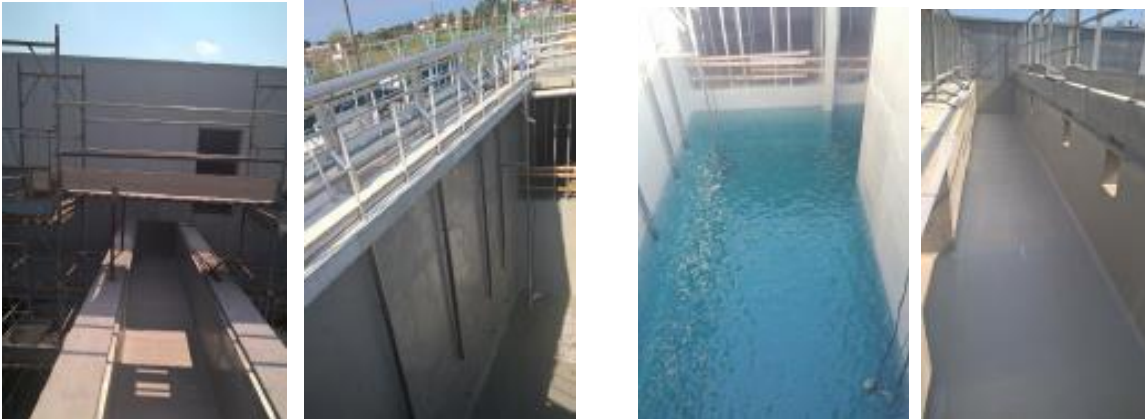
Our reference in  
Cittadella (Italy):  
Drinking Water Treatment Plant

After comparing various alternatives, the ideal solution was to apply an **hotspray polyurea waterproofing membrane**: MasterSeal M 689. MasterSeal M 689 was applied by means of a suitable two component heated, high pressure, proportioning spray equipment. The application was done by an expert company that could solve all technical requirements at the jobsite.
